Manhole Inspection Summary

Manhole # S49GG_015MH

Insp Date: **8/11/08 10:20 AM**

Location Address: **Rose**

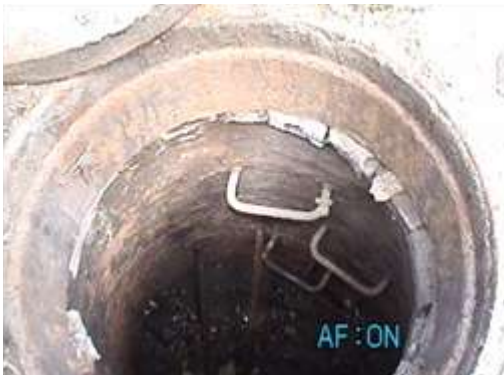
Defect 1

frame leaks

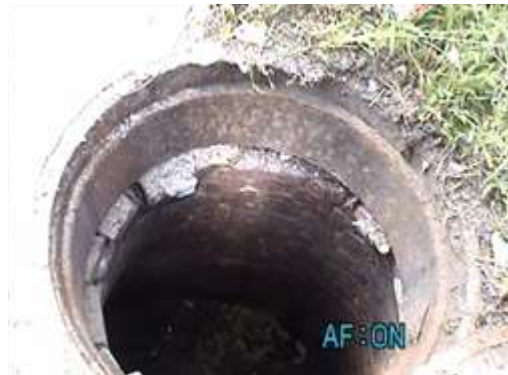
Defect 2

Condition: ☐ Sound ☐ Cracked ☐ Root Intrusion ☒ **Loose Brick** ☐ Deteriorated

Infiltration: ☐ None ☐ Joint ☐ Cracks ☒ **Mortar** ☐ Roots ☐ Wall

loose brick

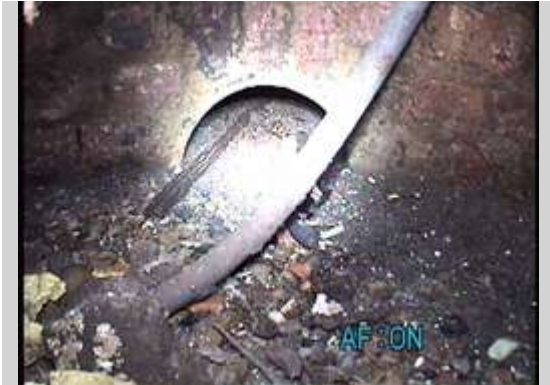
12 O'Clock Outflow

8 in. Circular Gravity Sewer
Pipe Out @ 12 O'Clock

Infiltration: **None** Pipe Seal Cond: **Sound**
